What happened to the Sultana?

27 April 2015 Patrick Jennings

Hartford Steam Boiler

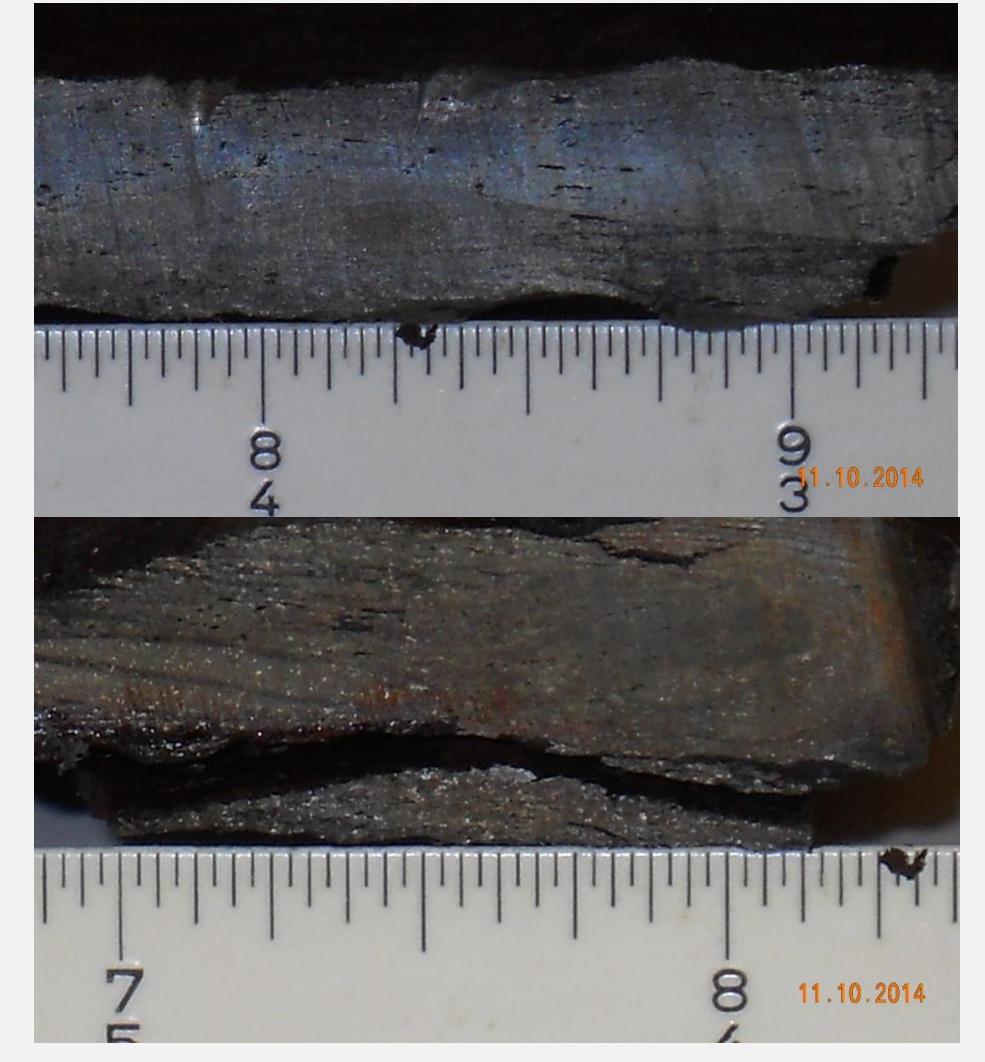
Charcoal Hammered No. 1 (Wrought iron)

- Inclusions
- Brittle
- By 1879
 - "...not a suitable iron for boiler construction"
 - "...having but little elasticity and breaking with a sudden jerk".
 - "brittle character and unfit for use in a boiler"
- Replaced by "Flange Iron"

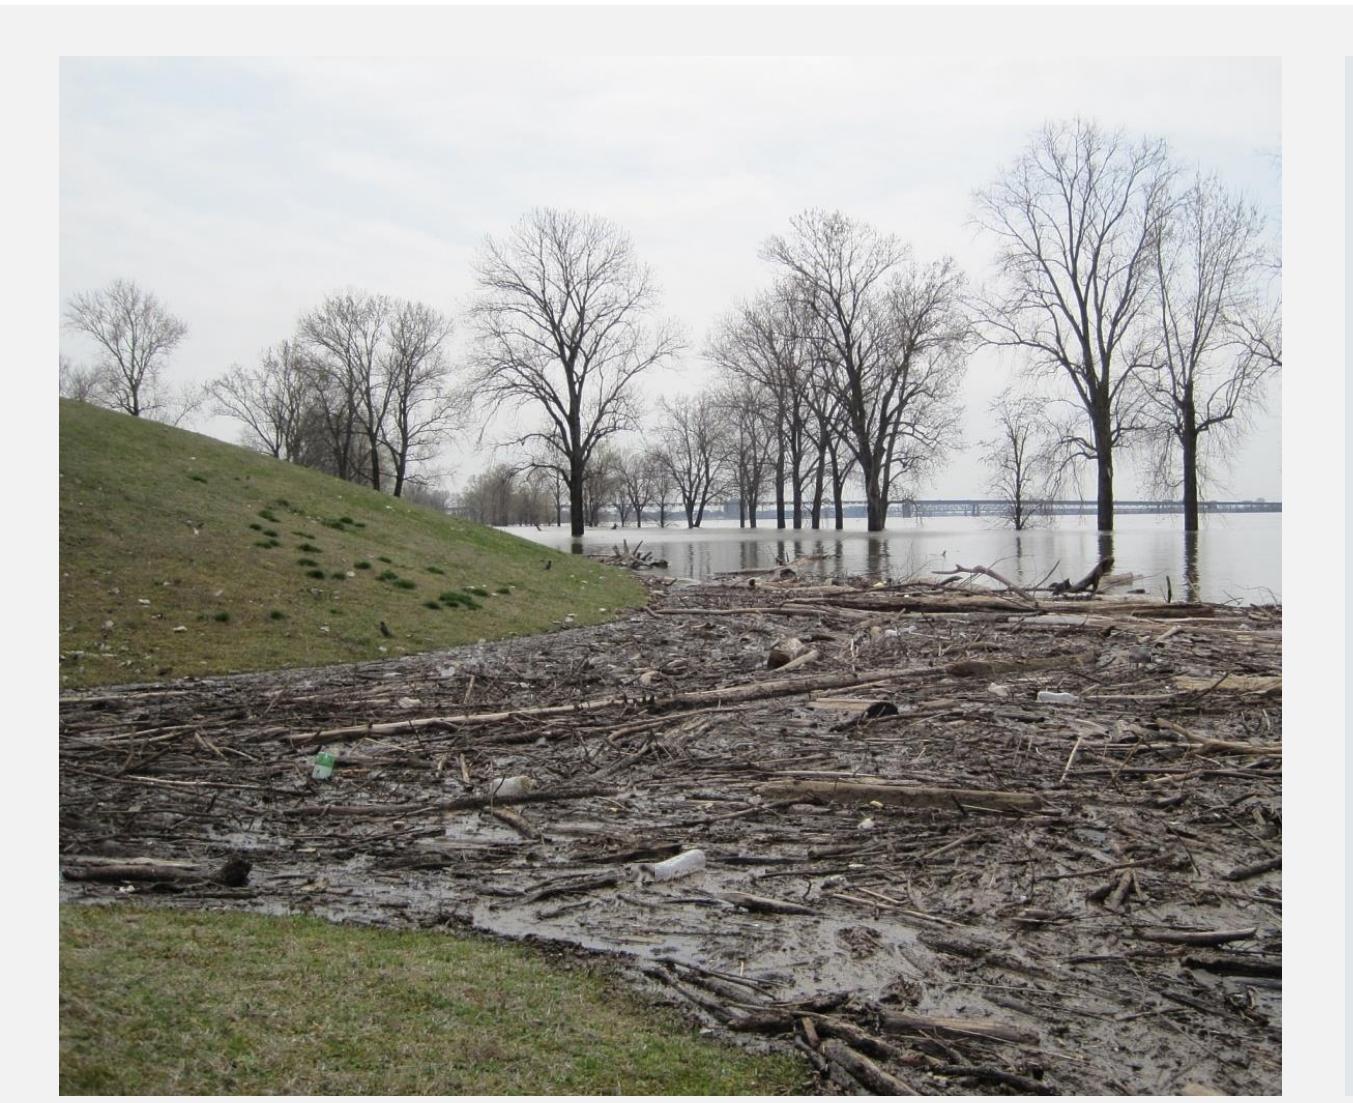
Mississippi River Water

- Boiler Make up straight river water
- Boilers cleaned in New Orleans and then again in Vicksburg
- 500 mg/liter (2011 USGS Data)
- ½ lb sediment per
 1000 lbs water

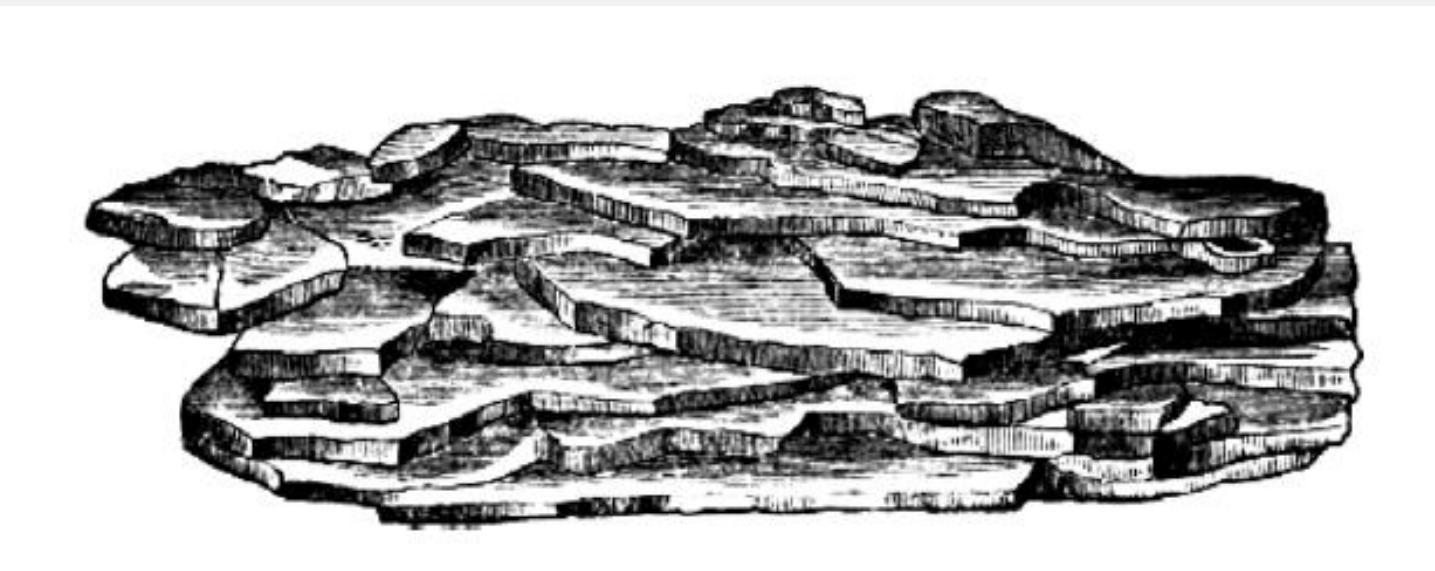
Fig. 73.

The whole bottom of a boiler is sometimes injured, and the plates buckled and the seams sprung, from the accumulation of mud. One case may be mentioned where the water was

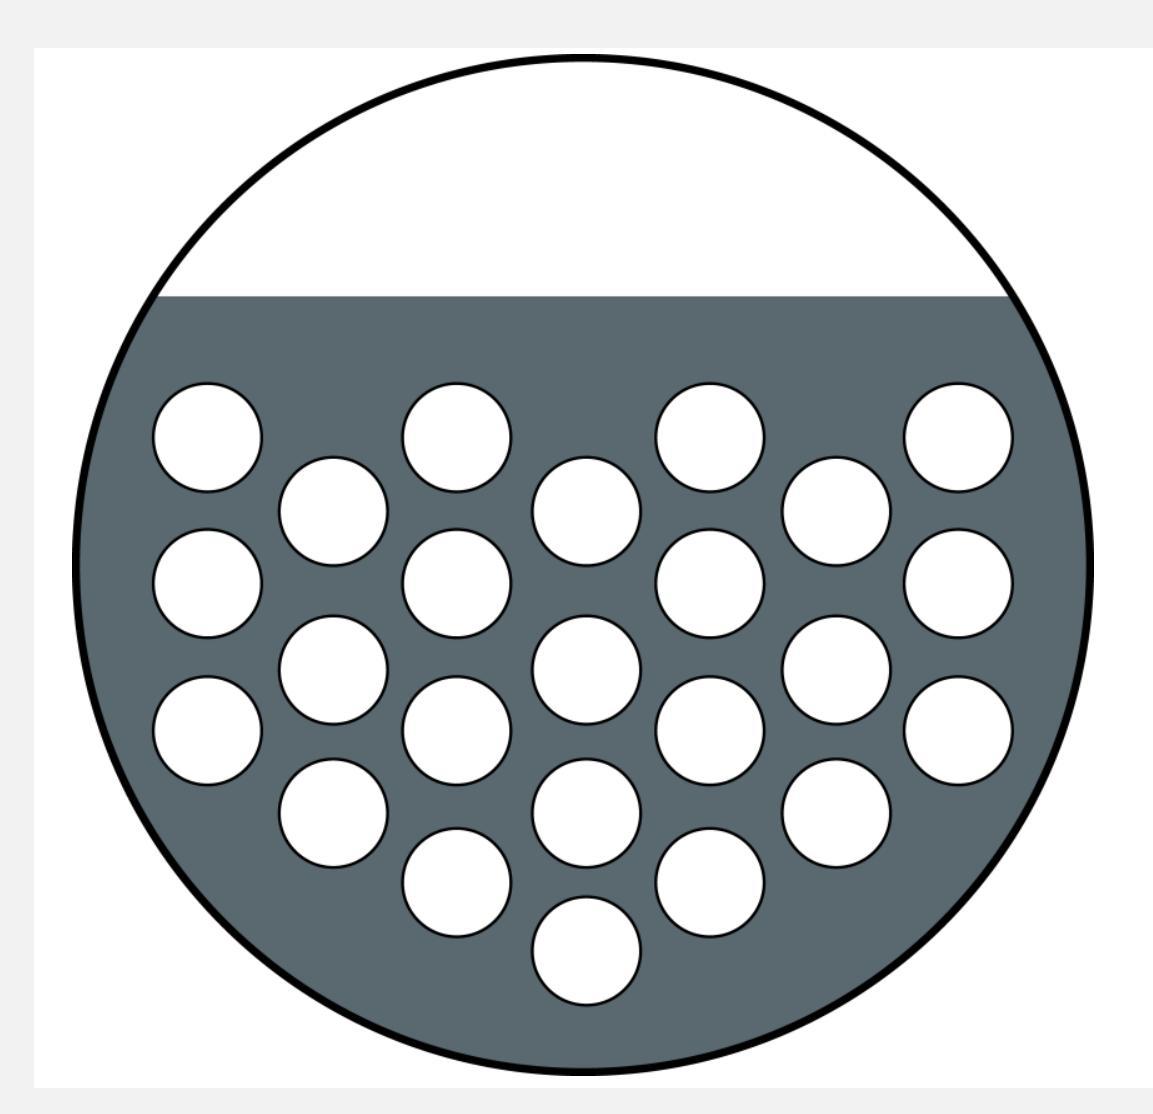
Boiler Design

- 24 5″ Tubes
- Bottom cleaned by a shell broom
- Top small boys scrape them down
- 1866 3 Additional explosions of tubular boilers
- Rapid removal of tubular boilers from the Mississippi River
- Single Lap
