THE NATIONAL BOARD

NATIONAL BOARD TASK GROUP LOCOMOTIVE BOILERS

AGENDA

Meeting of August 27th, 2020 Virtual Meeting using Zoom

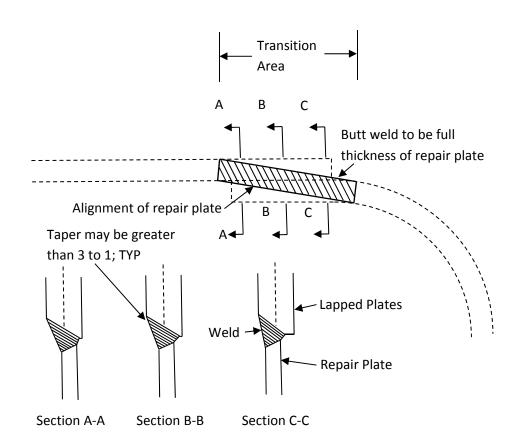
Add a sentence in S1.2.11.5 i); Replace drawing in Figure S1.2.11.5-c1 with new drawing below.

S1.2.11.5 REPAIR OF FIREBOX, WRAPPER, AND TUBESHEET KNUCKLES

i) For one-piece flange knuckle joint patches in portions of a riveted lap joint or in mud ring corners with a lap joint in the firebox, the knuckle patch shall be supported on at least one of the two planes adjacent to the flange, by means other than the weld. See Figure S1.2.11.5-c1. The weld shall be at least the full thickness of the new plate being installed. Taper of weld in transition area may be greater than 3 to 1. Volumetric examination is not required. This type of repair shall be considered a repair.
